PETER BARRY  
CHARTERED SURVEYORS

LEVEL 3

# Your survey report

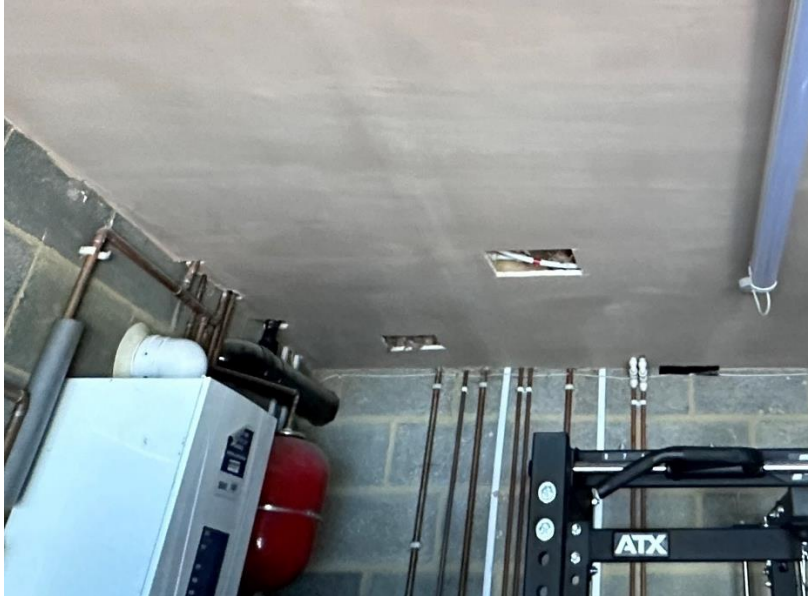
The ceiling in the garage should be formed with a double layer of 12.5mm plasterboard or of a fire resistant plasterboard to provide adequate separation between the space and the habitable rooms above. The ceiling is boarded but there are holes cut into it that appear to have been formed for access to sections of pipework. These should either be sealed or if future access is desired finished with some form of proprietary fire resistant hatch. I cannot confirm by visual inspection whether the boarding is of suitable fire rated specification. See comments under Section H1 regarding Building Regulation approvals.

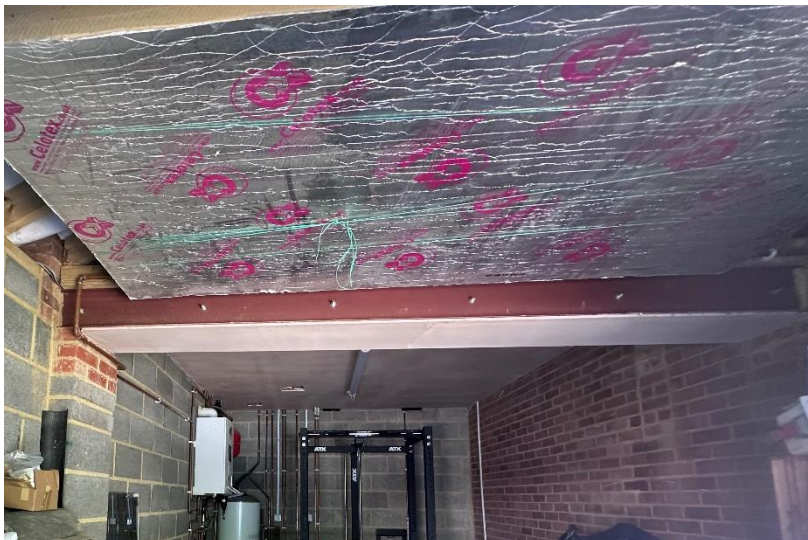
The full perimeter of the steel beam supporting the front wall above the garage should also be enclosed by fire resisting boarding. The front facing side has been left open.

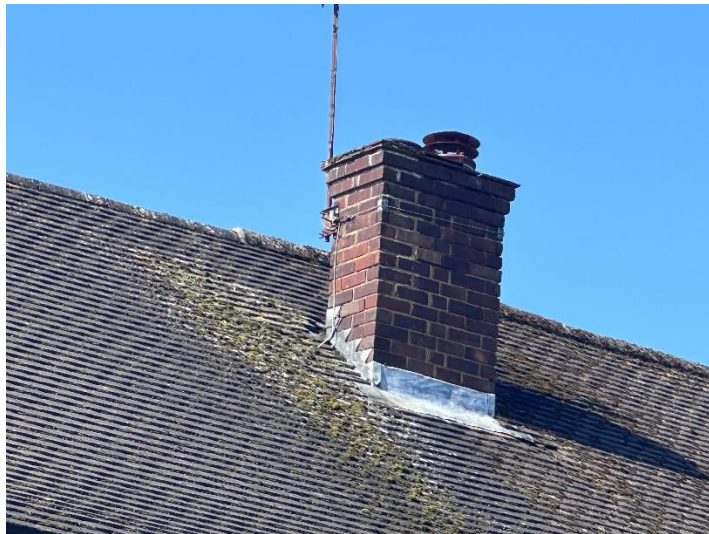
It is of brick construction with a clay pot. There are lead flashing and a lead lined back gutter at the junctions with the tiles.

There are some areas of the mortar pointing to the brickwork that are starting to wear. This does not need immediate attention but this will deteriorate over time such that some patch repointing will be required within the next 2 to 3 years. Worn mortar should be raked out to a minimum depth of 25mm and renewed with a matching mortar mix. **Condition rating 2.**

The flashings are in sound condition, although the back gutter could not be seen from available vantage points.

As noted later there is no fire in the fireplace position to the living room such that the flue is currently disused. Where there are dis-used flues that are open at pot level I would suggest they be fitted with ventilator caps. Whilst no associated issues were noted, this will help to prevent the ingress of rainwater and maintain ventilation to avoid dampness building up inside the flues and creating problems internally.

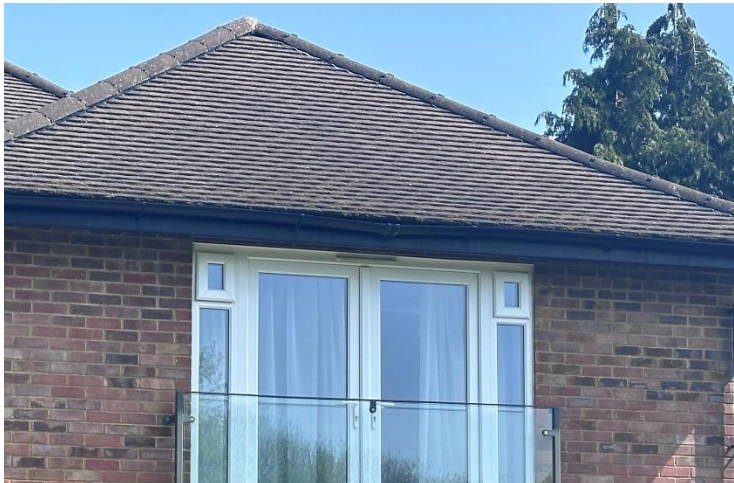
These fittings are in sound condition, but there is a sag in the line of the gutter above the casement doors to the rear of bedroom 1. An additional bracket is required at this gutter joint position.

**Condition rating 2.**

Ongoing routine maintenance will be required. The fittings should be inspected at least once a year and accumulated leaves, silt and other debris be removed from the gutter, downpipes and gullies/channels to prevent blockages.

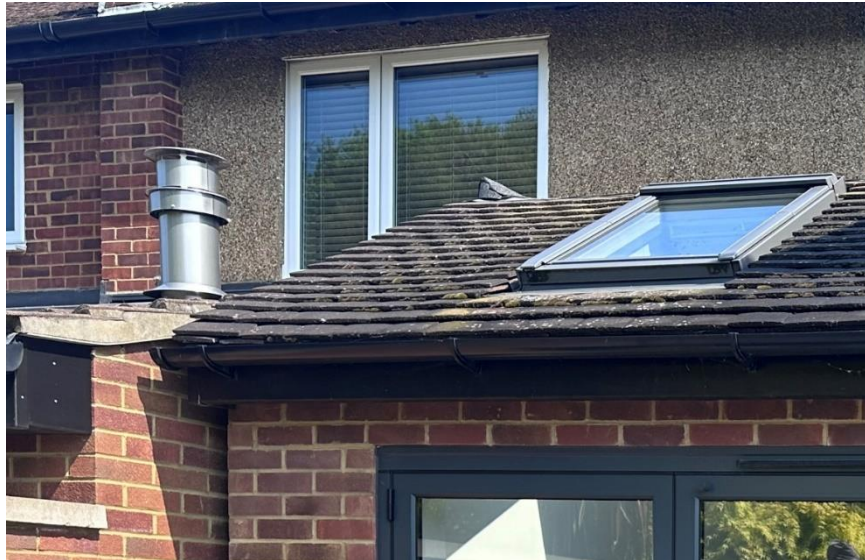
There is some form of vent terminal or flue that passes up through the roof slope to the single storey extension to the rear of no. 26. If this is an extractor flue this is not problematic. If it is a flue for a gas appliance or solid fuel appliance, then it is relatively close to the rooflight to the rear of the dining area and could present a risk of flue gases entering the property. Enquiries should be made with the adjoining owner.

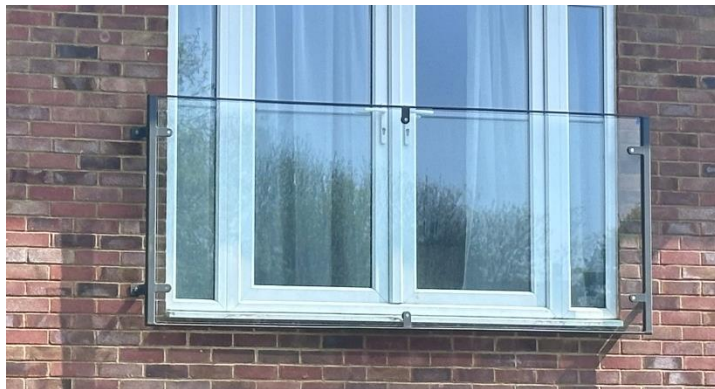
It is in a sound condition.

From a safety perspective, although the balustrading is of adequate design and the fixings are not visibly loose, I am not able to confirm the quality, depth and strength of the fixing points. As a precaution I would recommend that you undertake a risk assessment by means of a professional lateral load/strength and fixing pull out test.

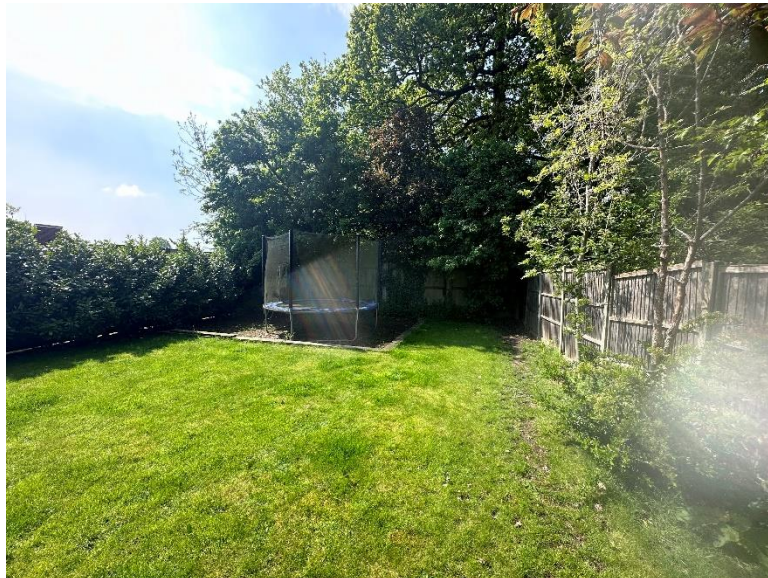
There are boughs that overhang the rear boundary.

Falling branches or trees could present a serious safety hazard. I would recommend that you liaise with the owners of the adjoining site, which may be the Council, to ensure that there has been and will be periodic risk assessment by a specialist tree surgeon or arboriculturalist.
